FINAL DESIGN REPORT / ENVIRONMENTAL IMPACT STATEMENT

Appendix L – Bridge Information

Highway Project
P.I.N. 1721.51
BINs: 1033141 / 1033142
Interstate 87 (I-87) Exit 4 Access
Improvements
Albany County

BIN 1033141

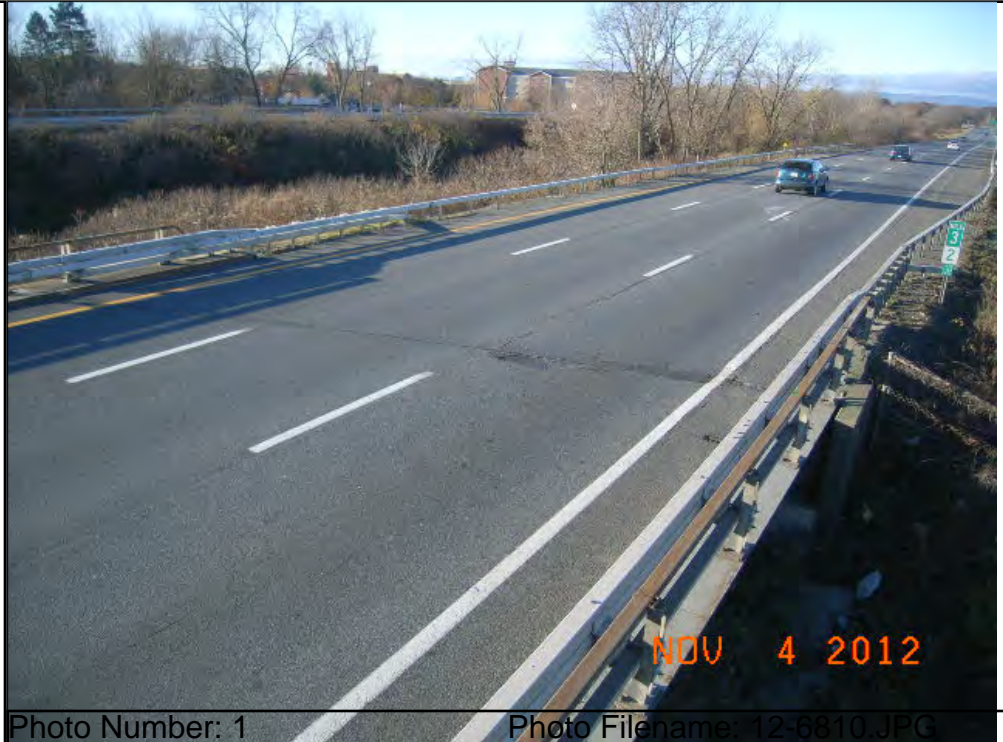
Photo Number: 1

At the Begin Abutment, there are asphalt patches in the Left lane and mapcracking on either side of the joints - ride is somewhat rough in the Left Lane. There is little indication of water leaking through at the Begin Abutment at this time. Photos 1 & 2. The rating at the Begin Abutment is reduced from 5 to 4 due to the ride quality, especially for high-speed traffic.

Abutments - Joint with
Deck - Begin - Overview
from above left
Approaches - Pavement
- Begin - Overview from
above left

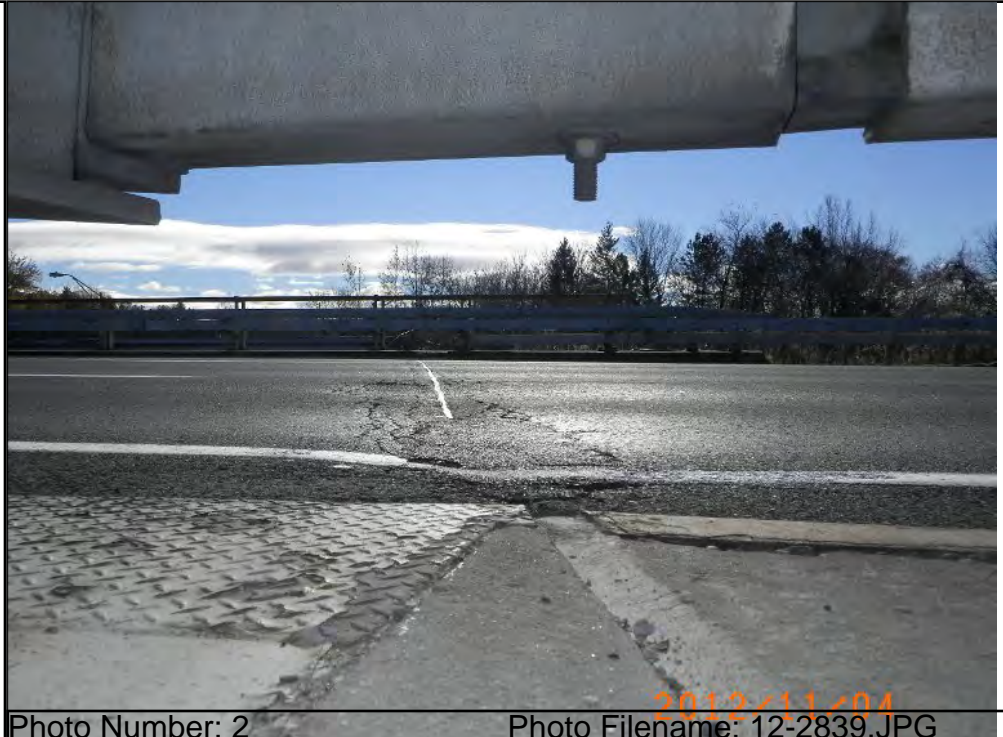
Photo Number: 2

Abutments - Joint with
Deck - Begin - across top
of surface from left edge
Approaches - Pavement
- Begin - across top of
surface from left edge

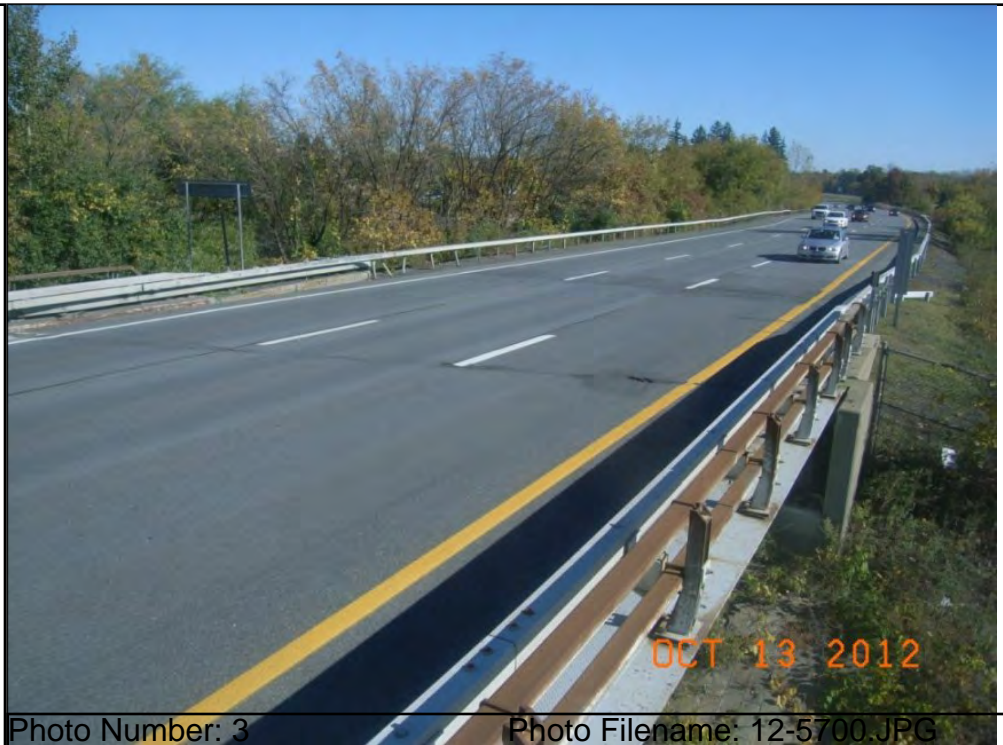
Abutments - Joint with
Deck - End - Overview
from above right
Approaches - Pavement
- End - Overview from
above right

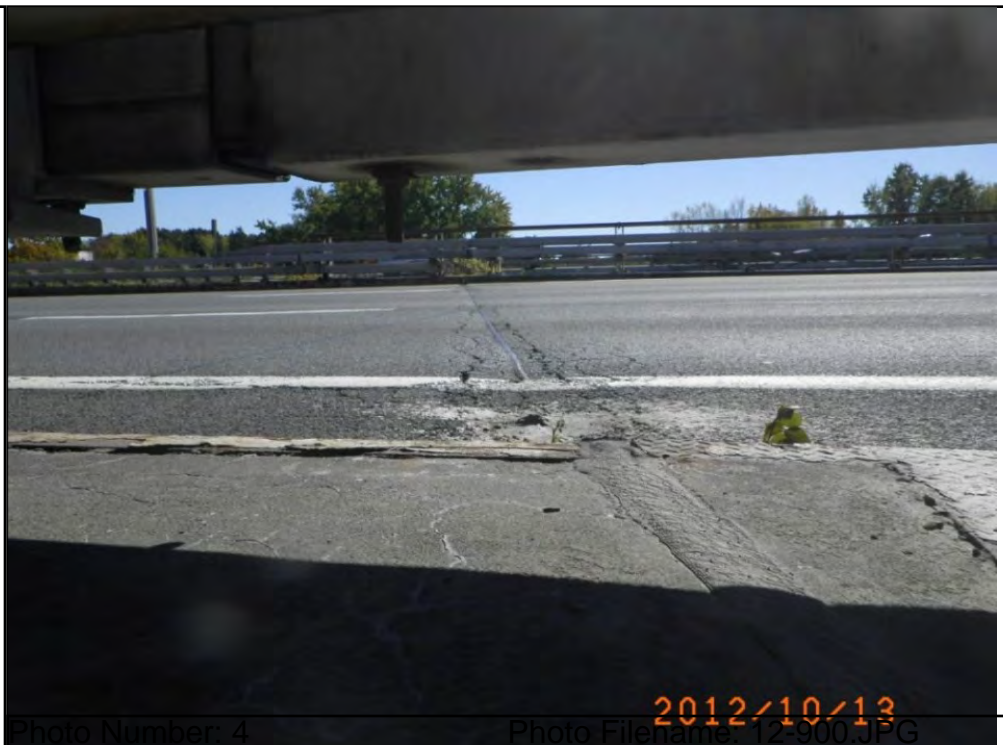
At the End Abutment, there is asphalt cracking and settling along the right side for a length of 10 ft, starting at the curb - Photo 4 <12-900>. Below on the Bay 5 backwall, there is full height, heavy efflorescence staining with small areas of delaminated concrete. Otherwise, there are no other indications of water leaking through. The rating at the End Abutment is retained at 4 due to ride quality and evidence of leaking in Bay 5.

Abutments - Joint with
Deck - End - across top of
surface from left edge
Approaches - Pavement
- End - across top of
surface from left edge

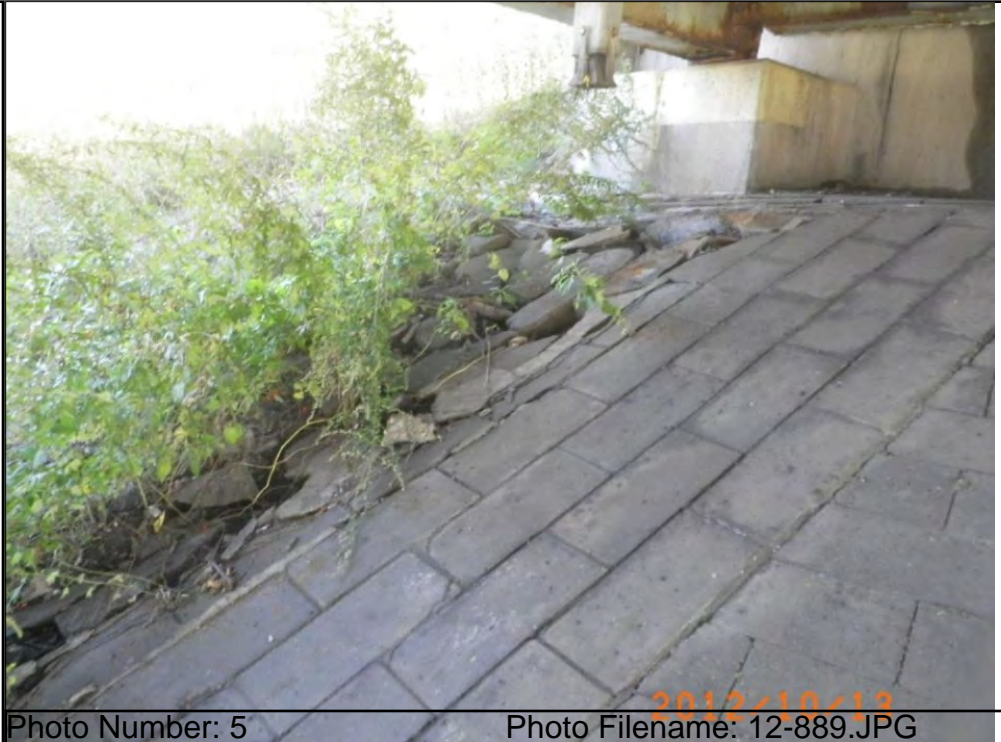
Photo Number: 5

Abutments - Erosion -
End Left

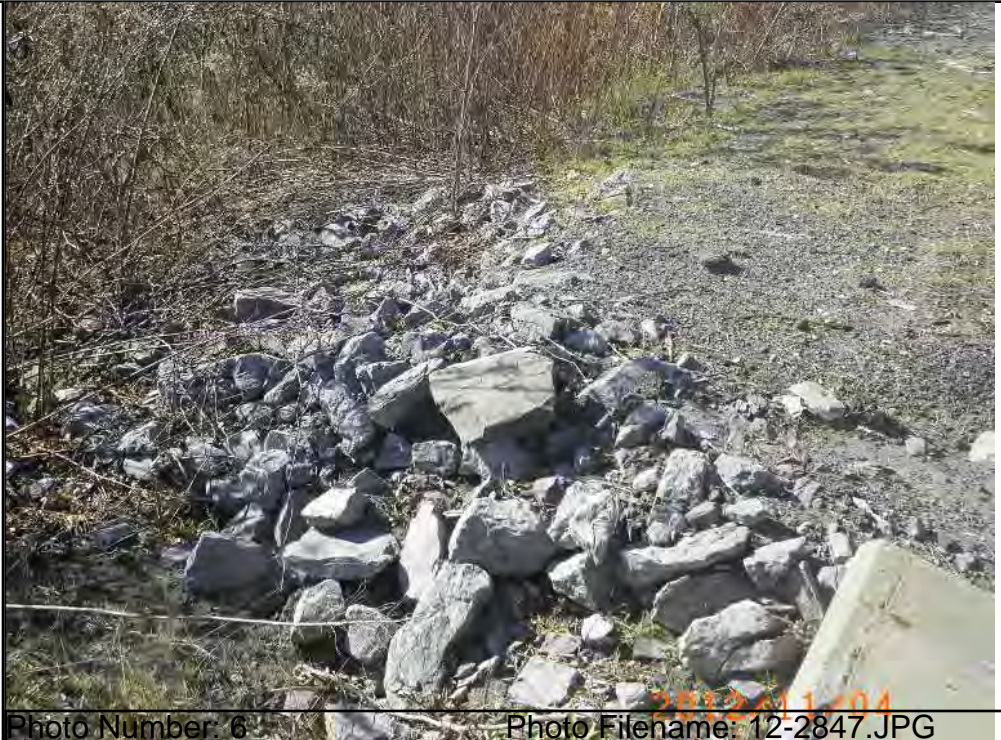
Photo Number: 6

Approaches - Erosion -
Begin Right in front of
wingwall

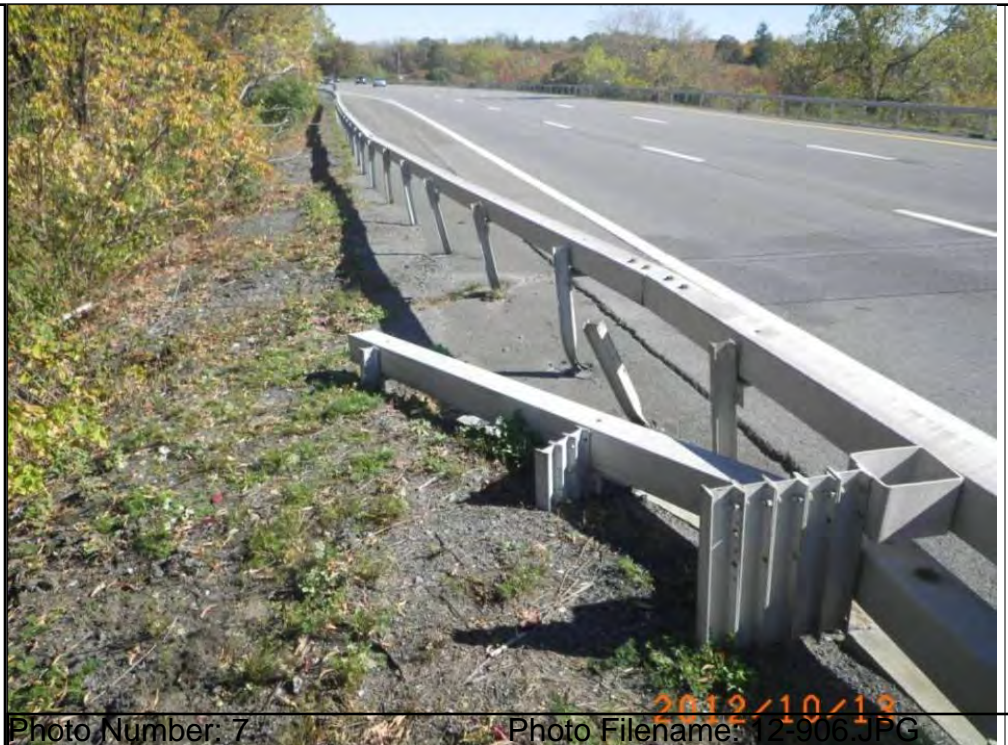
Photo Number: 7

At the End Left guide rail, the box beam and the first 6 posts have impact damage. Post 3 is severed at the base and the remaining 5 posts lean and twist to varying degrees away from the roadway. The rail is firm and appears to be still functional. The balance of the item would rate 5 or 6.

Approaches - Guide
Railing - End Left

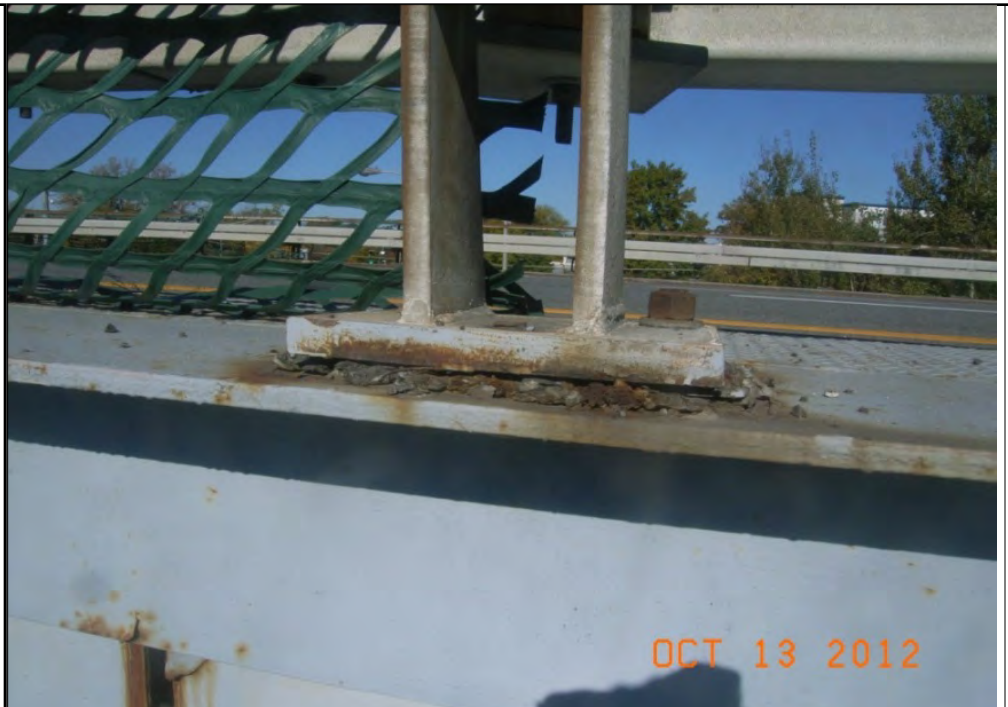
Photo Number: 8

In all 3 spans the bridge rail post anchorages are bolted through a steel plate support structure. There is a build-up of pack rust under the rail post base plates. This pack rust, potentially in combination with other forces, is causing failure of the rear anchor bolt at seemingly random post locations. The nut and shank break off of the bolt at the top of the base plate. There are a total of 3 anchor bolts per post; therefore, loss of one bolt is a significant effect on the capacity of the anchorage system. The bolts remain in place only by rust and friction. At those locations with broken bolts observed during this inspection, the nut and shank portion was missing - potentially having fallen off of the side to ground/roadway below, or onto the shoulder of the bridge deck. Hence, there is a significant risk of bolt pieces falling from Span 2 onto traffic below.

Deck Elements - Railing
- Span 3, Right, 1st post

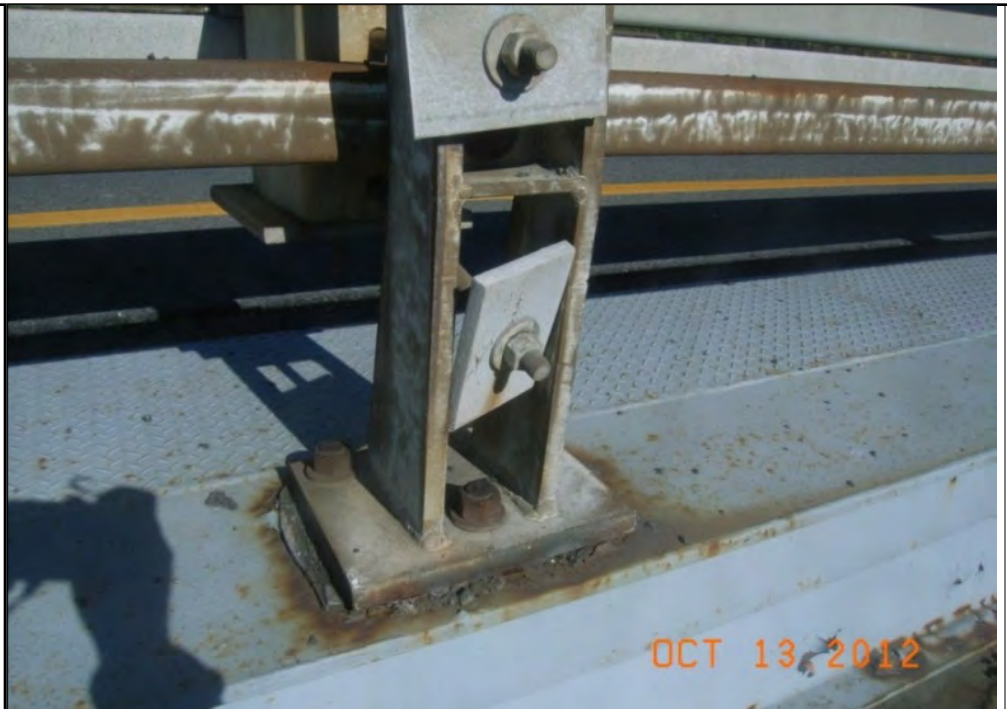
Photo Number: 9

Additionally - the bridge rail has been retrofitted in the past with a pair of box beams in front of the original 2 rail system. The extra box beams are anchored to the posts with bolts and plates on the rear face of the post. In some instances, the rear plates have become loose and rotated becoming partially or fully ineffective in anchoring the box beam. The following locations were noted:

Span 3, Left side, 2nd and 4th posts - loose plate, photo 9 <12-5703>.

Current conditions are not judged to warrant a flag, but should be reviewed carefully during subsequent inspections for additional examples.

Deck Elements - Railing
- Span 3, Right, 4th post
(Span 2 Right 2nd post
similar)

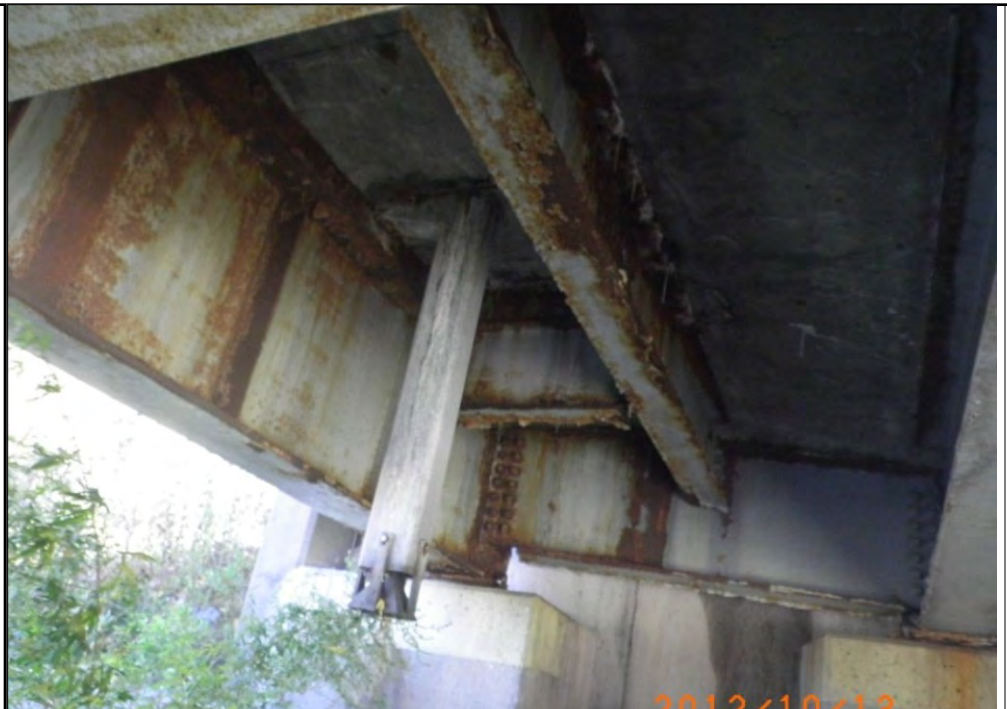
Photo Number: 10

Where the steel grating was replaced with concrete, the concrete deck in Bays 1 and 6 exhibit widespread cracking and deck leakage as evidenced by the rust and efflorescence staining and

stalactites. Several of the horizontal reinforcing bars are partially exposed with minor section loss. The concrete was hollow sounding at many locations; rates 3. See photos 10 <12-887> & 11 <12-6927>. The remaining bays exhibit widespread cracking with water and light efflorescence staining; would rate 4.

Superstructure -
Structural Deck - Span 3,
Bay 1 near end

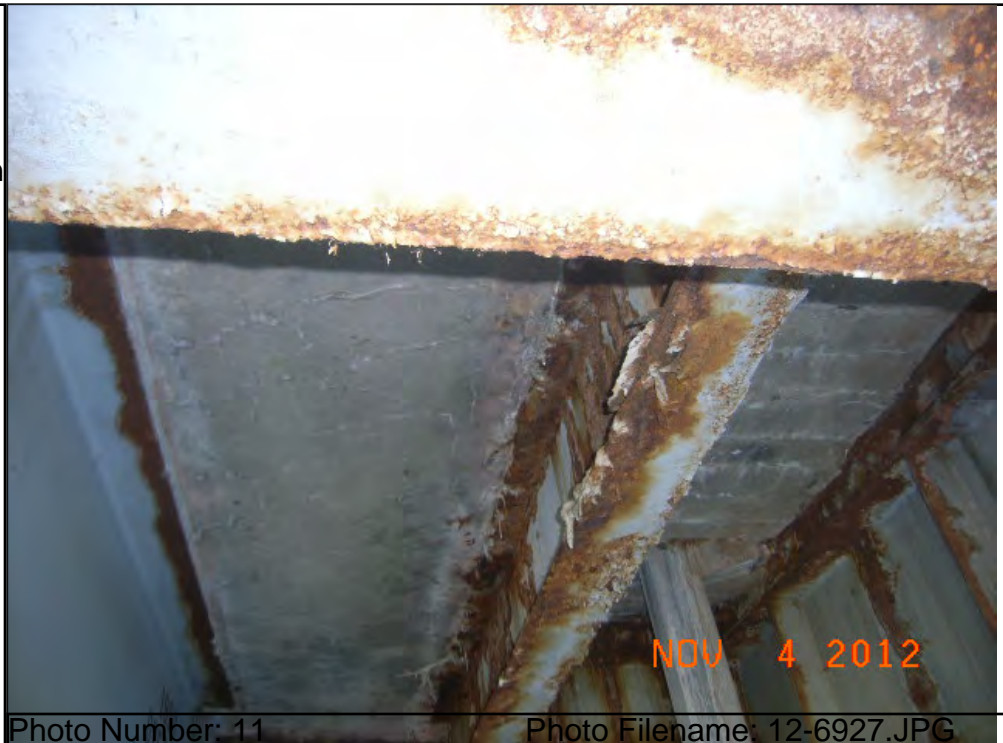
Photo Number: 11

In Spans 1 and 3, the stringers and floorbeams that supported the previous steel grating in Bays 1 and 6 exhibit paint failure that has lead to some section loss of these steel members, however, the condition rating of 1 of the past two inspections is inappropriately harsh - raise rating to 3 inasmuch as the areas of complete paint loss are localized and not widespread. See Photos 11 <12-6927> & 15 <12-887>.

Superstructure -
Structural Deck - Span 1,
Bay 5 near Begin
Superstructure - Paint - -
Span 1 - Bay 5 near Begin

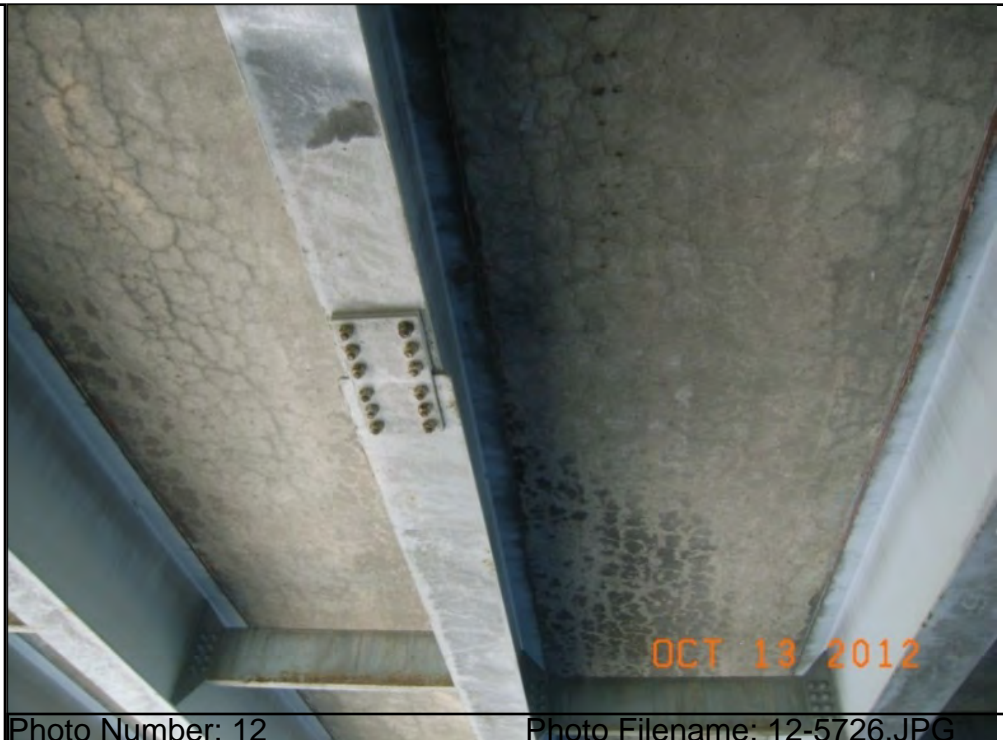
Photo Number: 12

There is widespread mapcracking with water staining and areas of light efflorescence staining; rates 4. See photo 12 <12-5726>.

Superstructure -
Structural Deck - Span 2,
end third, Bays 4 & 5

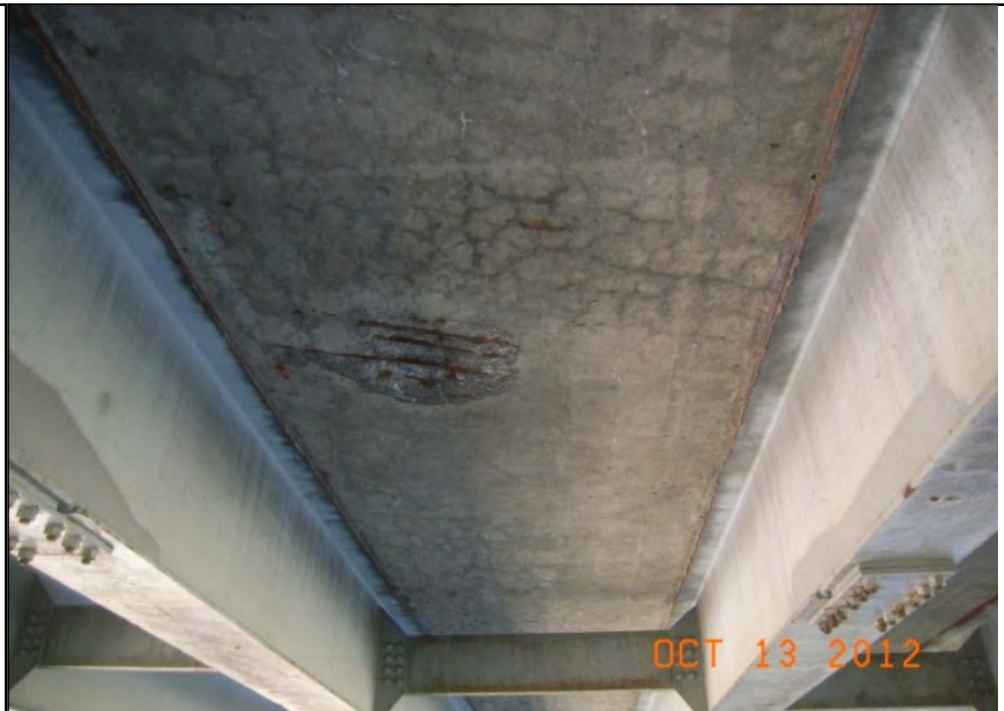
Photo Number: 13

In Bay 2 near Pier 2, there is a 24" long x 16" wide x 2" to 3" deep spall at the underside of deck. The 2011 inspection cited that loose concrete was removed within and around the spall during the inspection. The concrete within the spall was crumbly [probably moist also] and the surrounding concrete was hollow sounding. Accordingly, Safety Flag 1T110017 was issued due to risk of falling material onto Albany Shaker Road.

During this inspection, the concrete surface exposed during 2011 had hardened and no new loose concrete was dislodged even upon substantial hammering - photo 13 <12-5731>. Therefore, the previous safety flag is removed this inspection and no new flag will be issued at this time. Rate condition 4.

Superstructure -
Structural Deck - Span 2,
Bay 2 near End

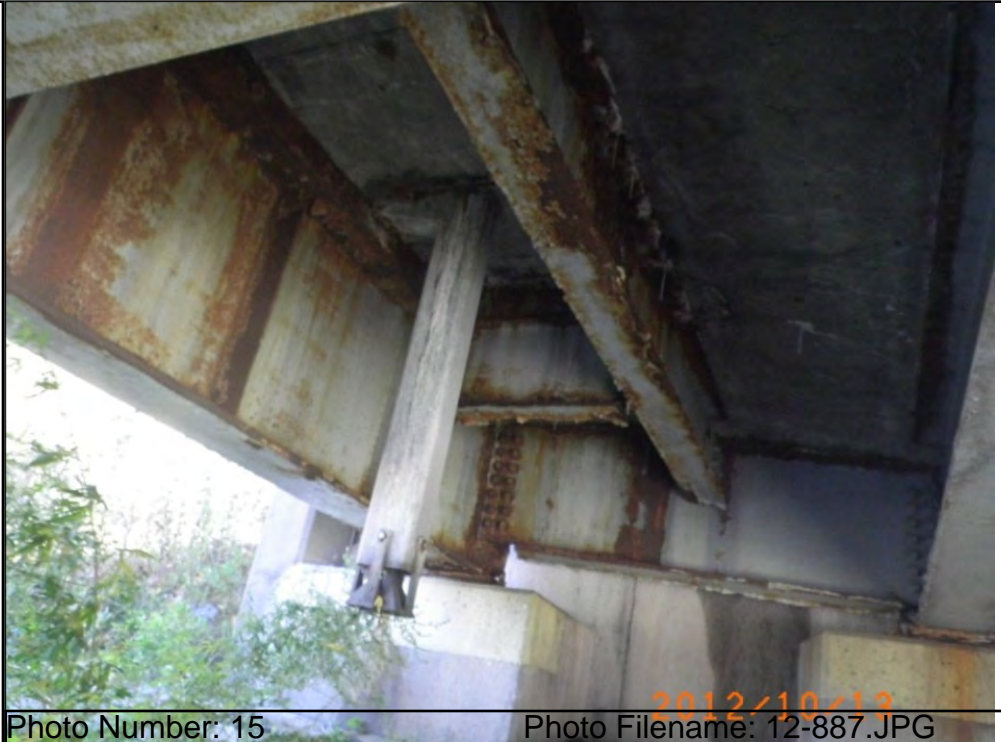
Photo Number: 15

Superstructure - Primary
Members - Span 3 - Bay
1, Panel 4, Intermediate
Stringer

Superstructure - Paint - -
Span 3 - Bay 1, Panel 4

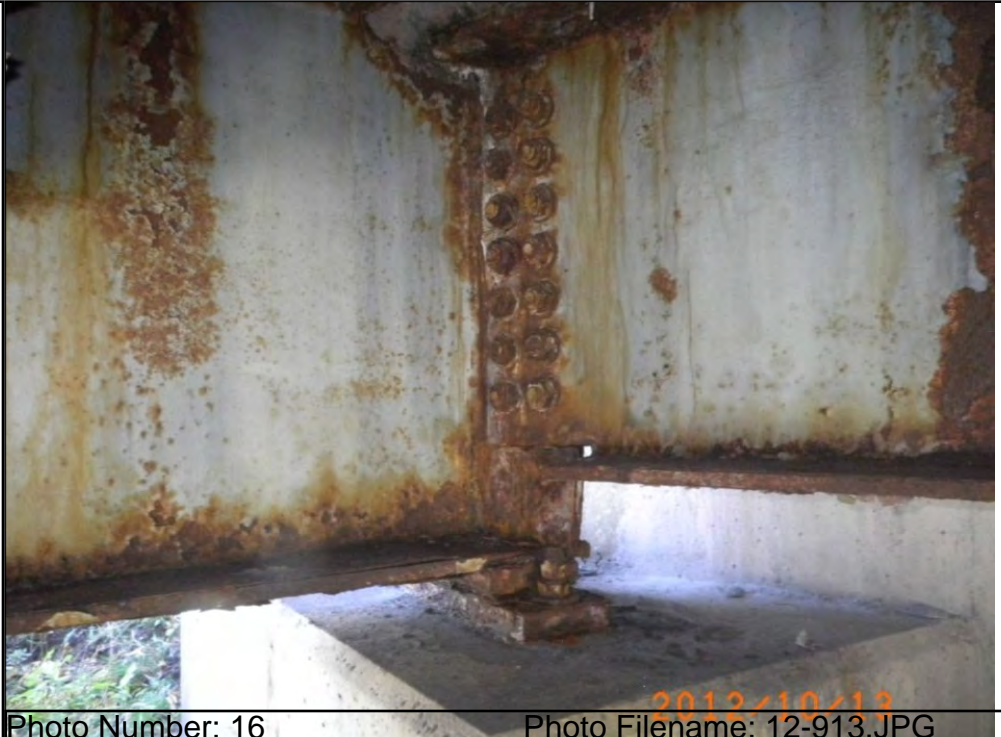
Photo Number: 16

- The bearing stiffener/end diaphragm connection plate at the right side end of Girder 1 in Span 3 is bent towards the end slightly, but noticeably below the diaphragm to the bottom flange - see photos 16 <12-913> & 17 <12-916>. This appears to be an as-built condition.
 - the girders have minor section loss from corrosion, especially on the outside of the fascia girders and on the webs/flanges near the ends from joint leakage.
- The girders would rate 5 overall.

Superstructure - Primary
Members - Span 3 - G1 at
End Abutment

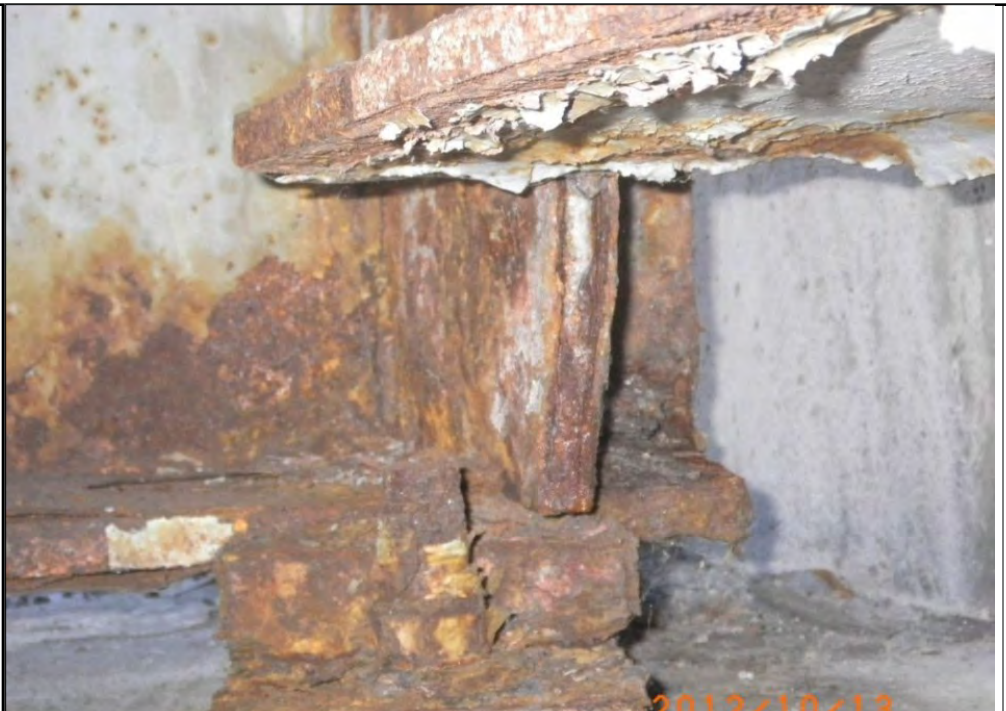
Photo Number: 17

Superstructure - Primary
Members - Span 3 - G1 at
End Abutment - bent
bearing
stiffener/diaphragm
connection plate

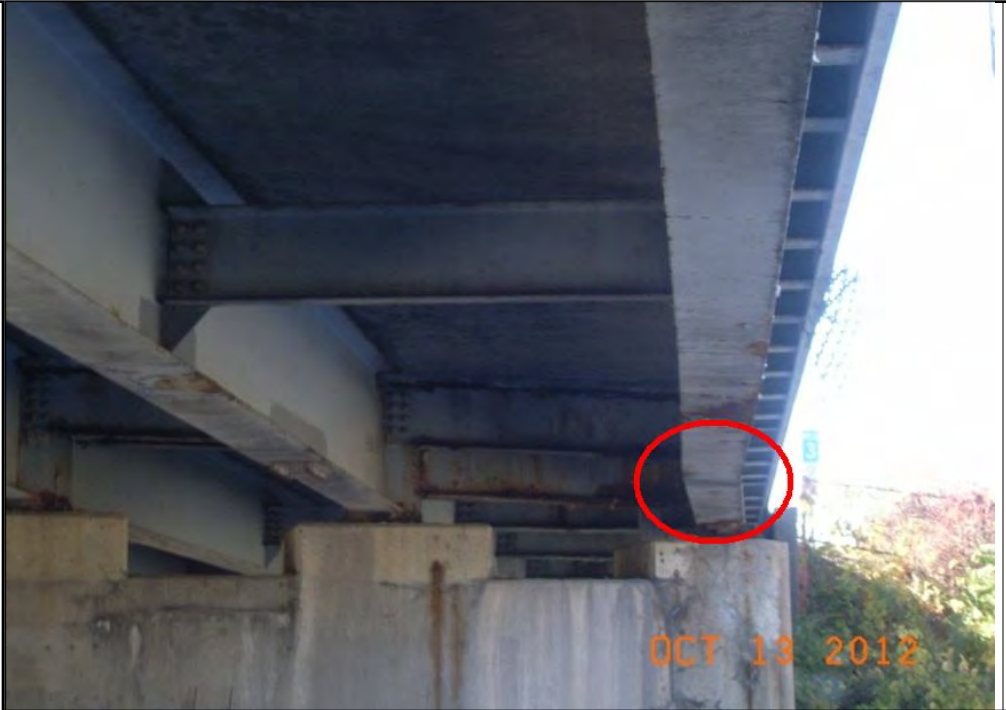
Photo Number: 18

In Span 2, G1 has a slight sweep due to previous impact damage and subsequent repair - no change from previous photos was observed - photo 18 <12-5756a>. All girders have scrape marks to the underside of the the bottom flange, but all exhibit corrosion that indicates that this is not a new condition. See photo 19 <12-6893>. The rating would be 5.

Superstructure - Primary
Members - Span 2, G1

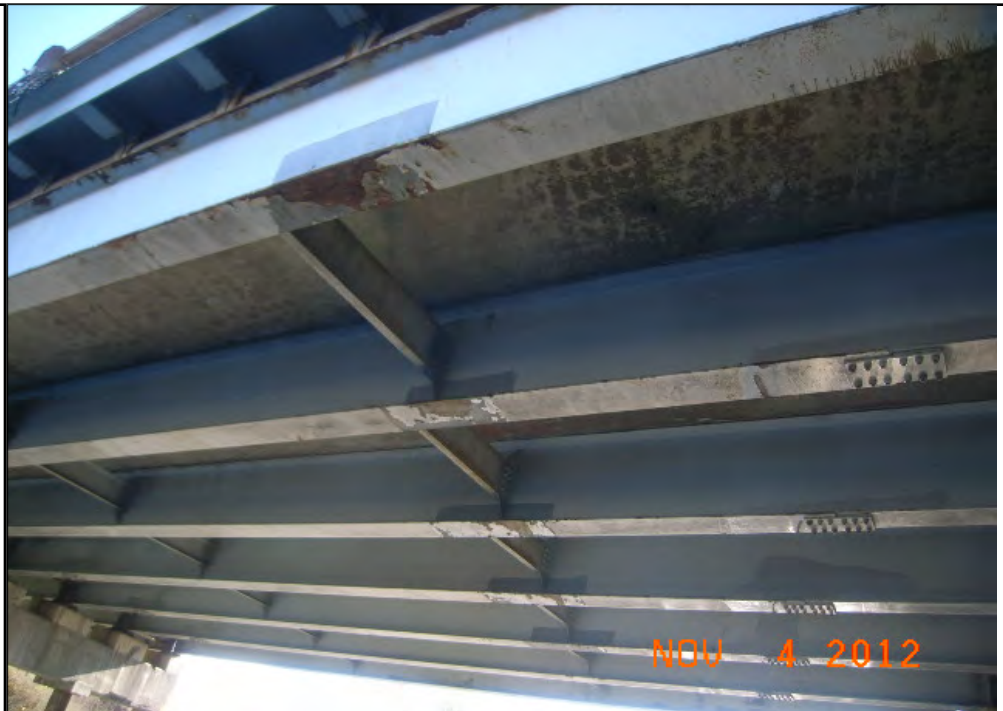
Photo Number: 19

Superstructure - Primary
Members - Span 2,
G1-G6, from Right
Superstructure - Paint -
Span 2

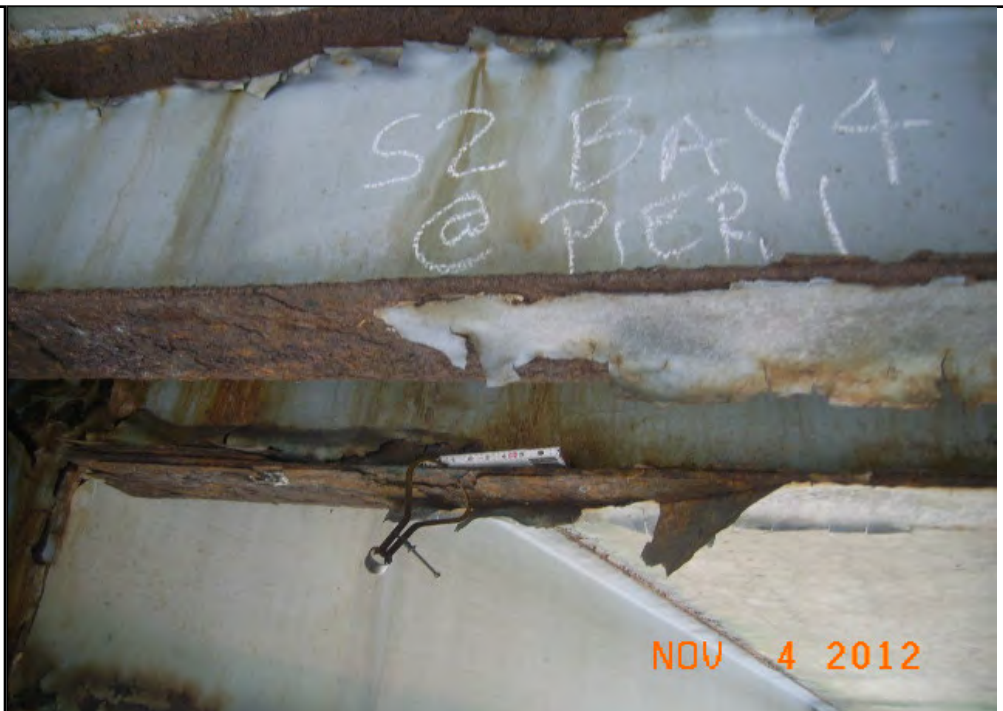
Photo Number: 20

The diaphragms at both piers for all three spans are corroded from joint leakage. At Spans 2 & 3, Bay 4 (above Pier 2), the bottom flanges of the diaphragms have lost up to 50% of its section - photo 21 <12-5721>. Spans 1 & 2, Bay 4 (above Pier 1) - similar to above - photo 20 <12-6856>.

The remaining steel members exhibit peeling paint in the outside bays and along the outside fascia beams. There is pinpoint corrosion along many portions of the top and bottom flanges of the interior beams and more extensive loss of paint and initial corrosion at all ends under the joints; would rate 4. See Photos 20 <12-6856>, 21 <12-5721>, 22 <12-5738> & 23 <12-5749>.

and pedestals exhibit varying degrees of deterioration, which may be an indication of water leaking through. The pier 1 joint is condition rating is maintained at 3. See Photos 20 <12-6856>, 28 <12-6839>, and 60 <12-6809>

Superstructure - Primary
Members - Bay 4 above
Pier 1 - Span 2 near side,
Span 1 far side.
Superstructure - Paint -
Spans 1 & 2 - Bay 4
Superstructure - Joints -
Spans 1 & 2 - Bay 4

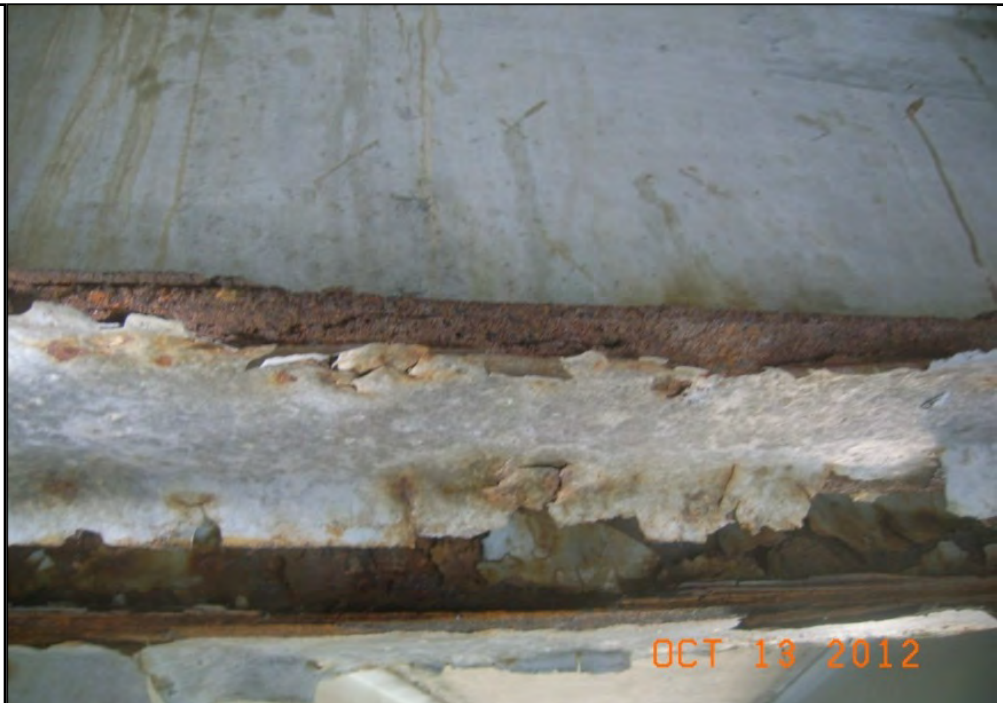
Photo Number: 21

Superstructure - Primary
Members - Bay 4 above
Pier 2 - Span 2 near side,
Span 3 far side.

Superstructure - Paint -
Bay 4 above Pier 2 -
Spans 2 and 3

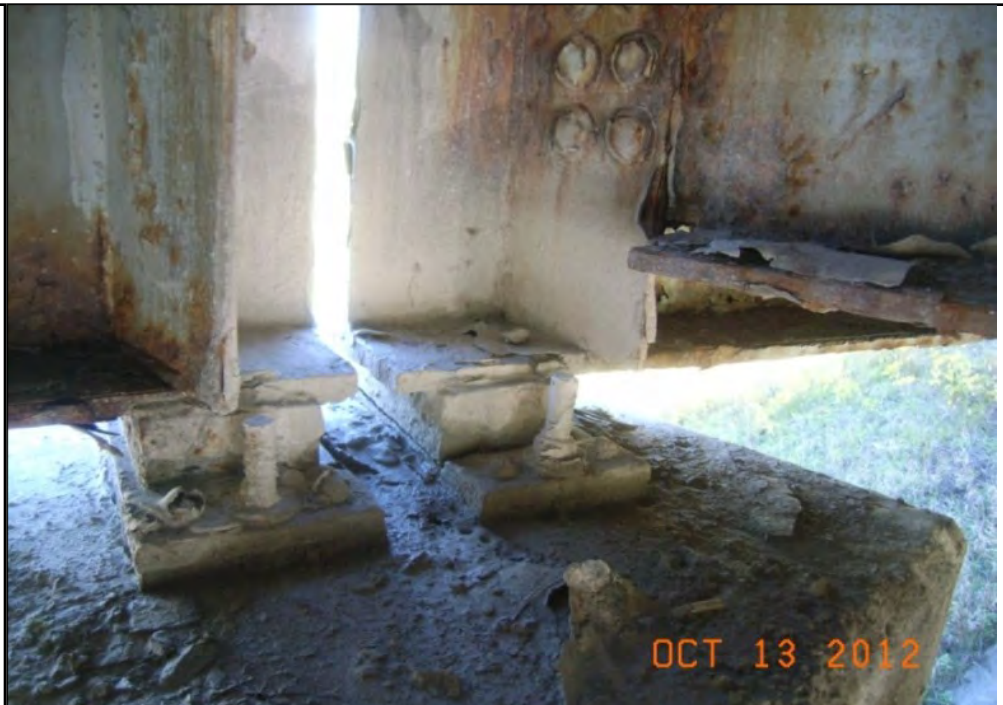
Photo Number: 22

Superstructure - Joints -
G1 Right face, Span 2 & 3
over Pier 2

Pier - Bearings - G1,
Span 2 & 3 over Pier 2

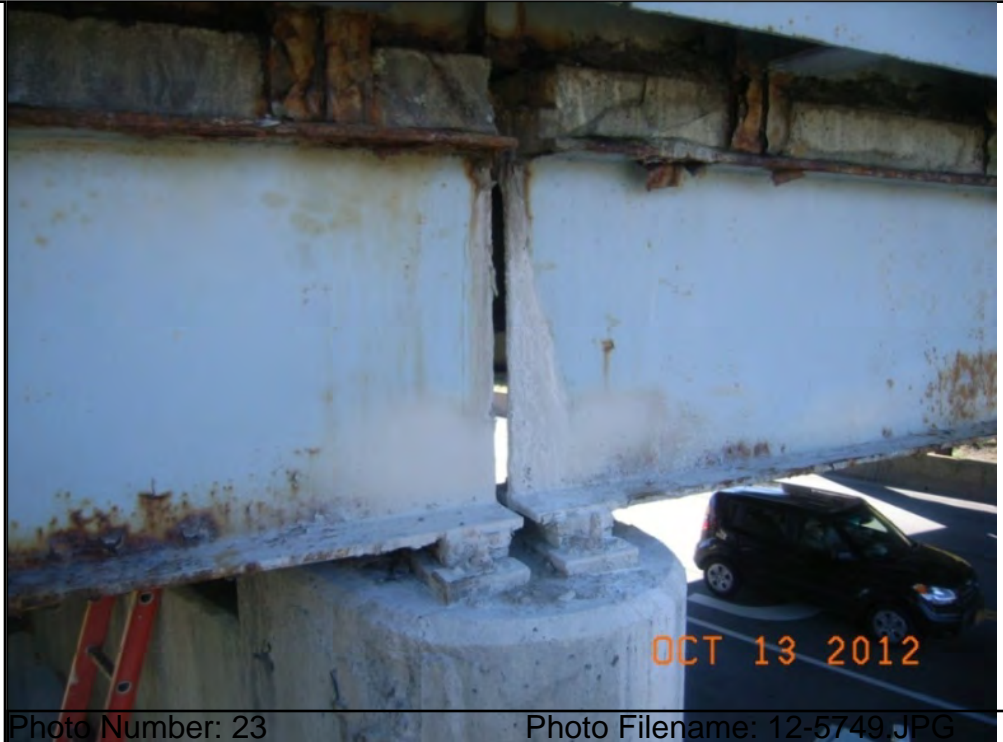
Photo Number: 23

Superstructure - Joints -
Left fascia - Span 2 & 3
over Pier 2

Deck Elements -
Railings - overview Left
fascia - Span 2 & 3 over
Pier 2

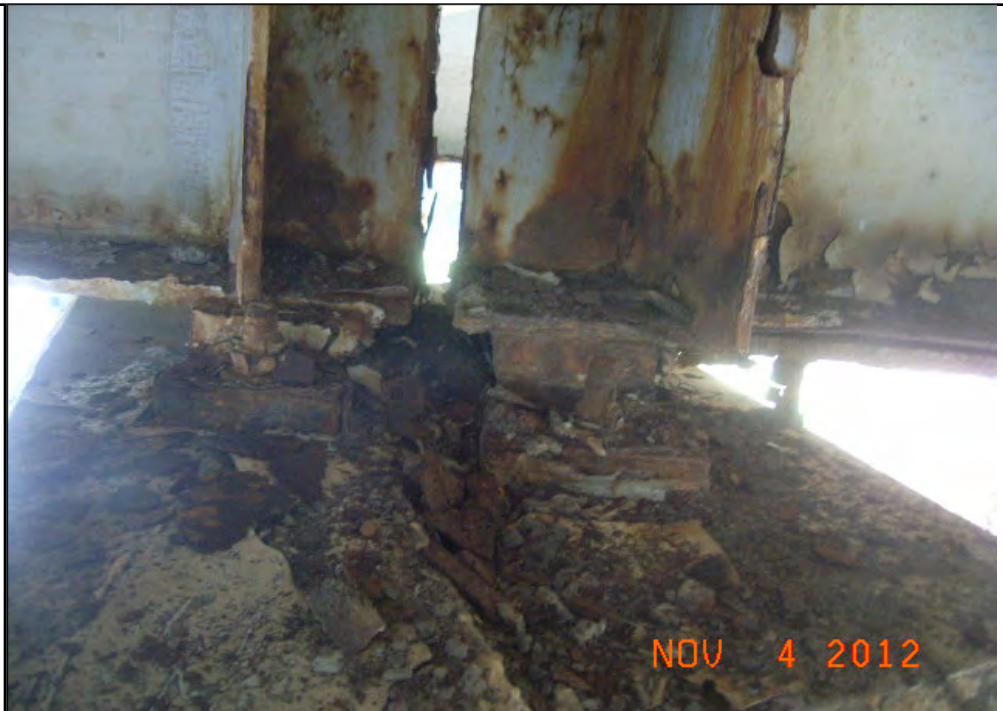
Photo Number: 24

Pier - Bearings, Bolts,
Pads - Pier 1 - G4, Right

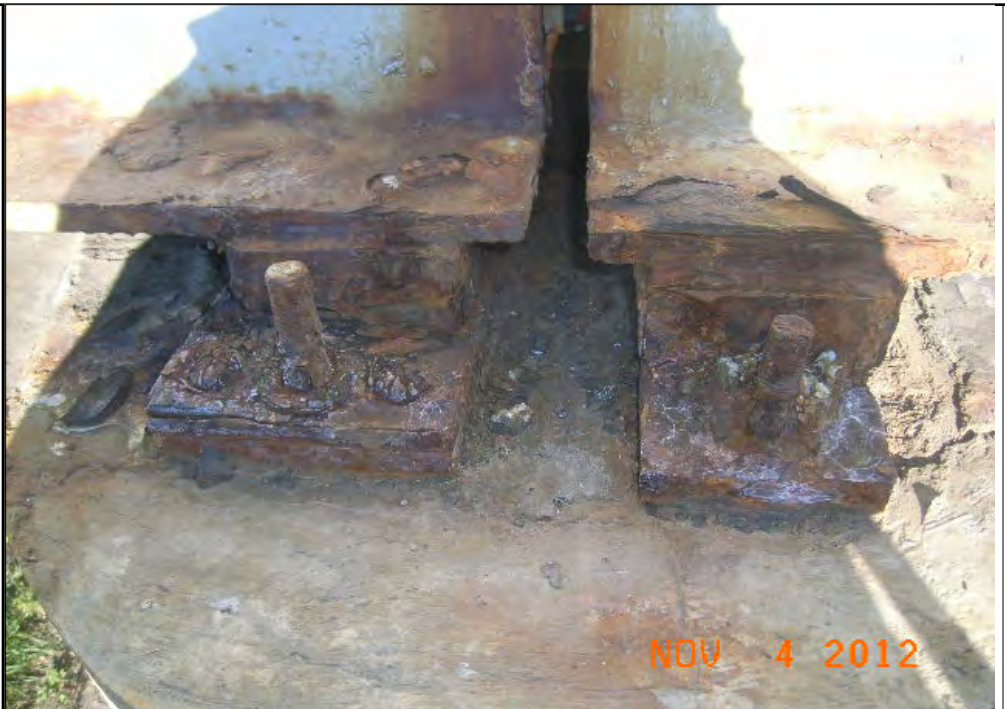
Photo Number: 25

Pier - Bearings, Bolts,
Pads - Pier 1 - G7, Right

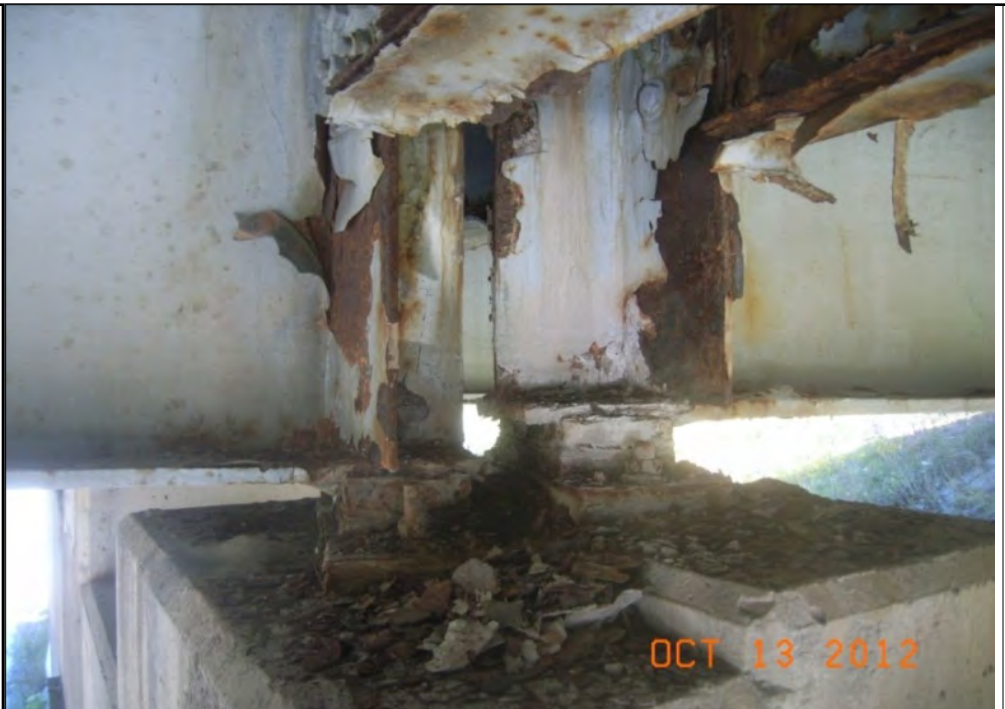
Photo Number: 26

Pier - Bearings - G3
Right, Span 2 & 3 over
Pier 2

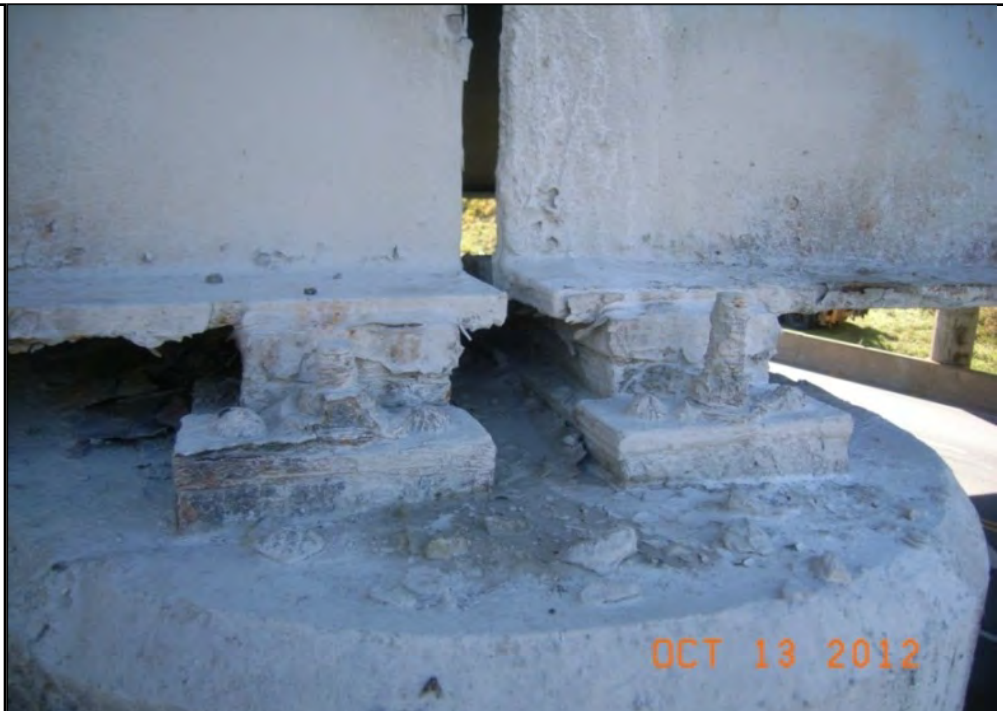
Photo Number: 27

Pier - Bearings - G1 Left,
Span 2 & 3 over Pier 2

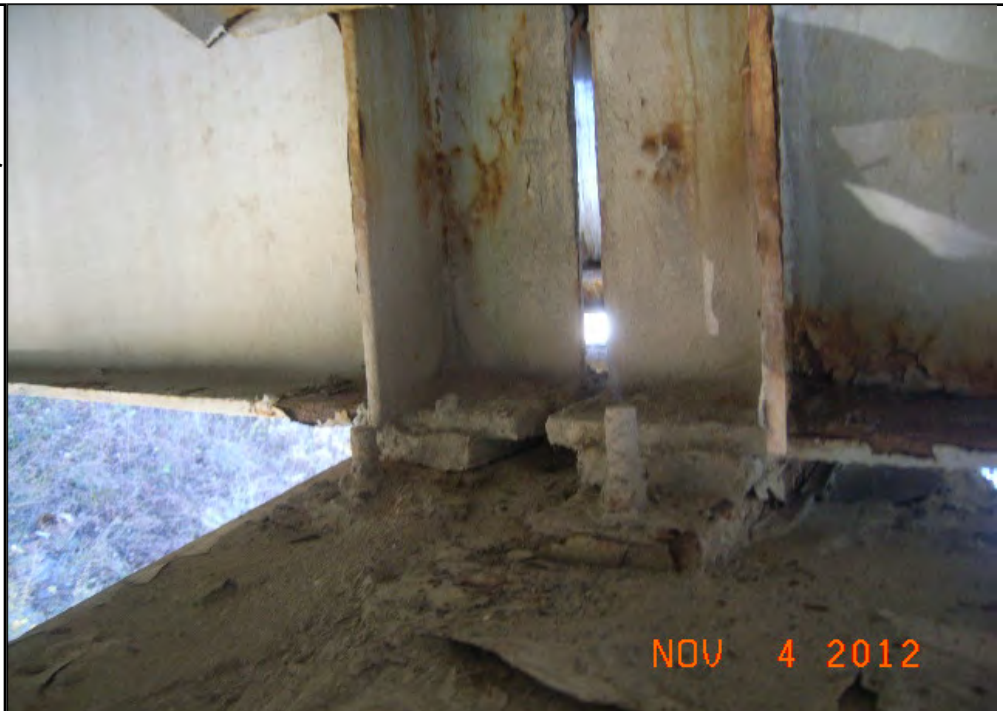
Photo Number: 28

Superstructure - Joints -
G2 Left face, Span 1 & 2
over Pier 1
Pier - Bearings - G2 Left
face, Span 1 & 2 over Pier
1

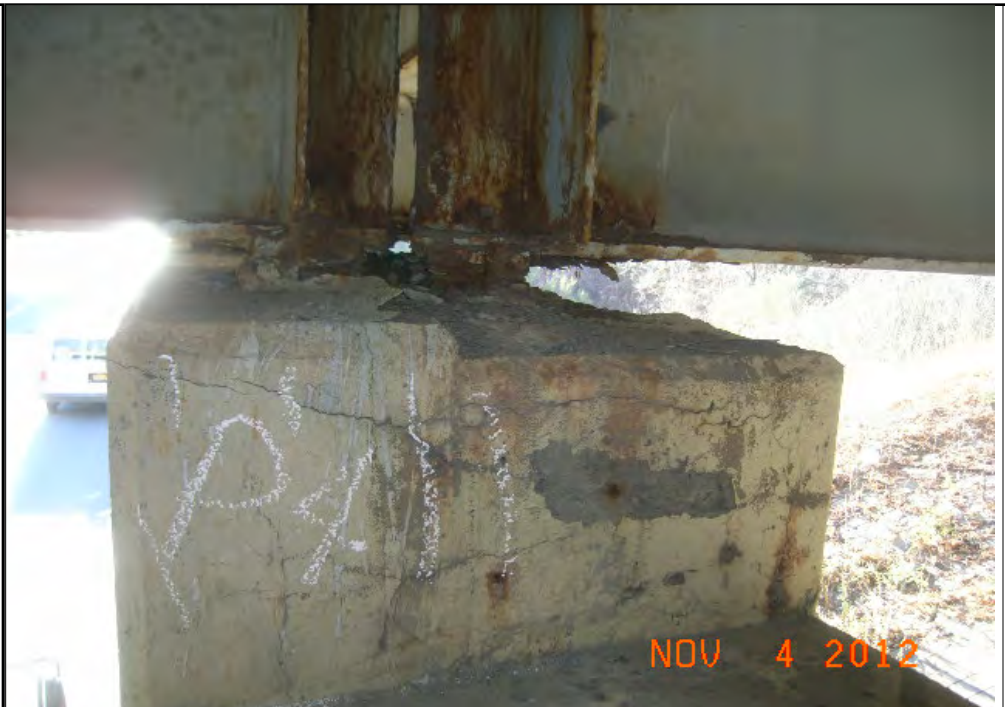
Photo Number: 29

Pier - Pedestals - Pier 1
- Ped 4 Left
